**Malcolm Morgan Marine / M³
Marine Electrical, Corrosion & Engineering Services**

**Limited Corrosion / Electrical / Shore Power Inspection
Honokohau Small Craft Harbor
May / June 2017**

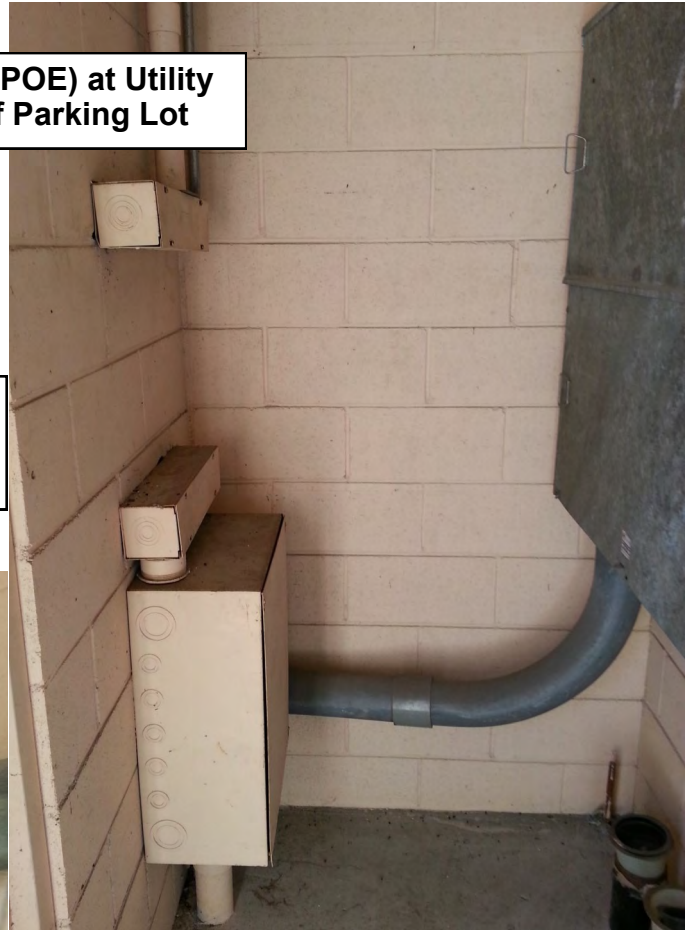
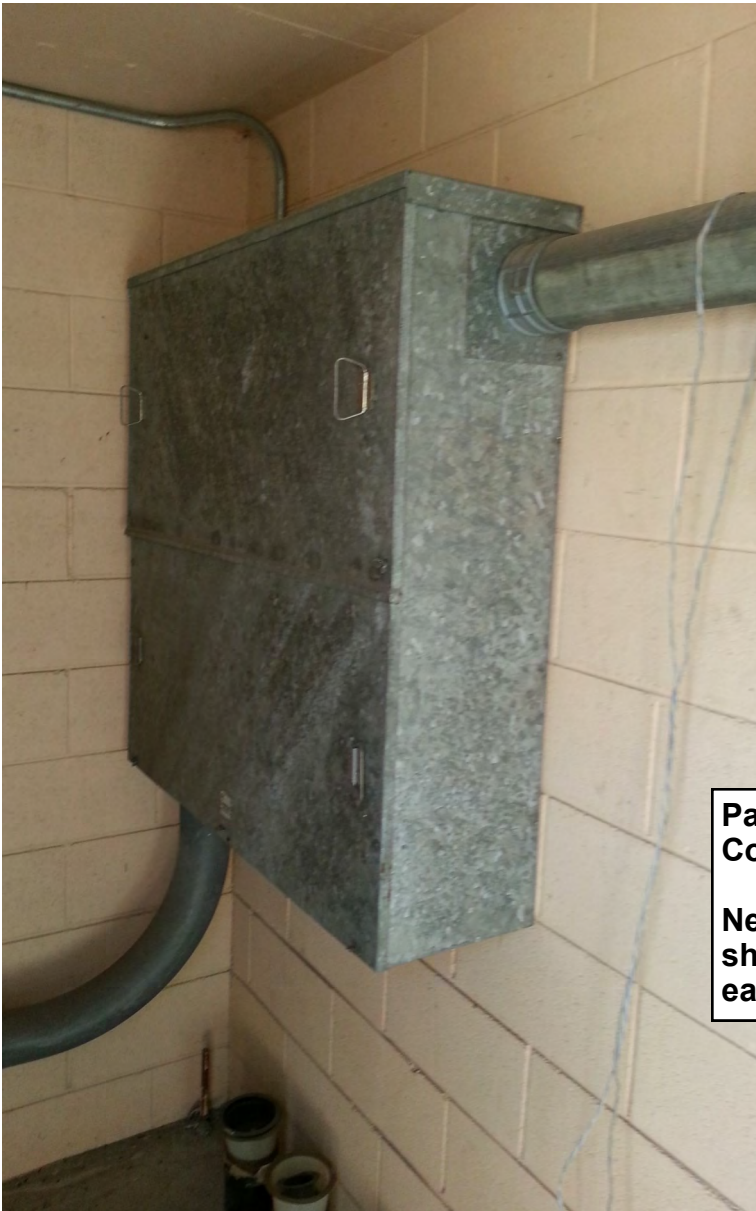
**Main Point of Entry (MPOE) at Utility
Shed on South Side of Parking Lot**

**All electrical connections required to be at
least 24" above the maximum highest flood
water level (PASS)**

**Panels and Enclosures Appear Serviceable
Condition**

**Need to clearly label dock emergency
shutoff breakers on outside of shed, and at
each enclosure**

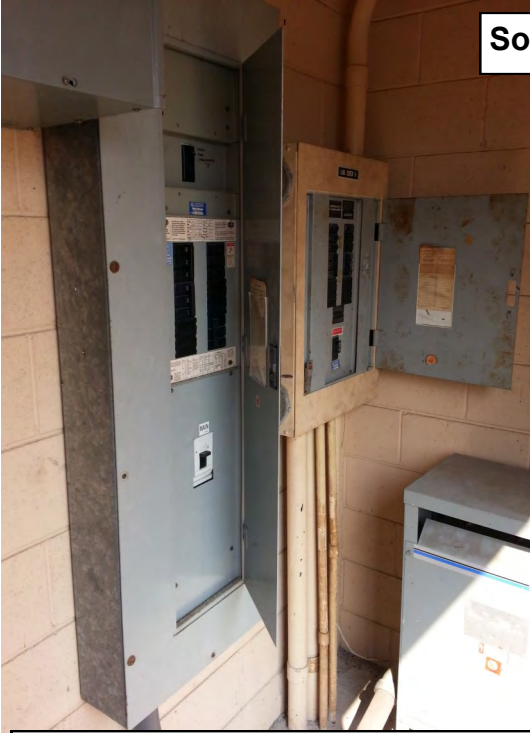
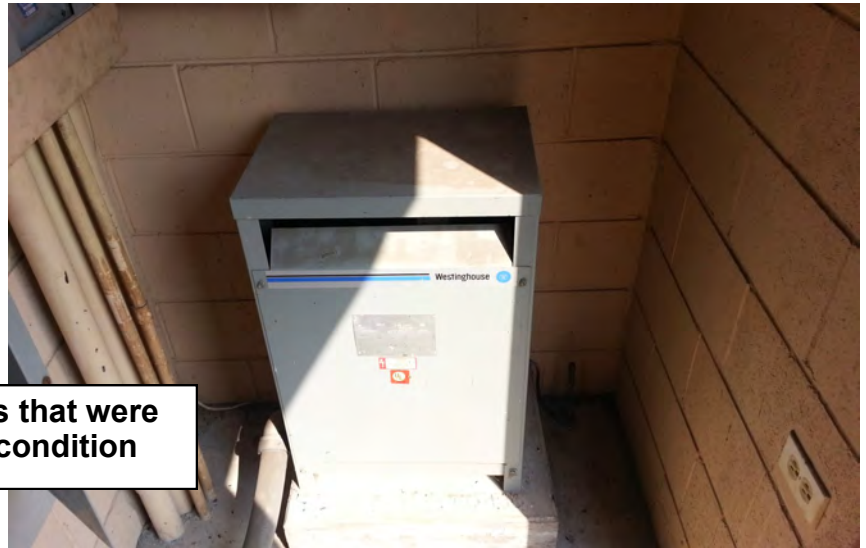
South Side Utility Shed :

All electrical connections required to be at least 24" above the maximum highest flood water level. (PASS)

All conduits, panels, junction boxes that were visible for inspection appear good condition

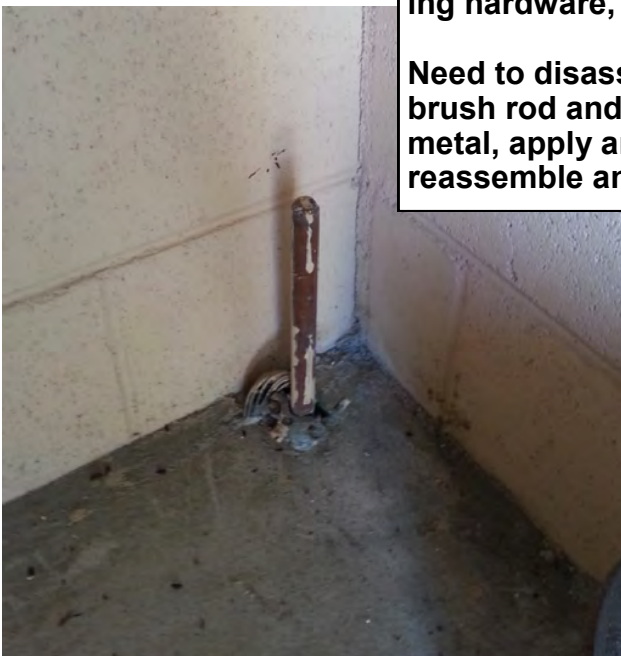
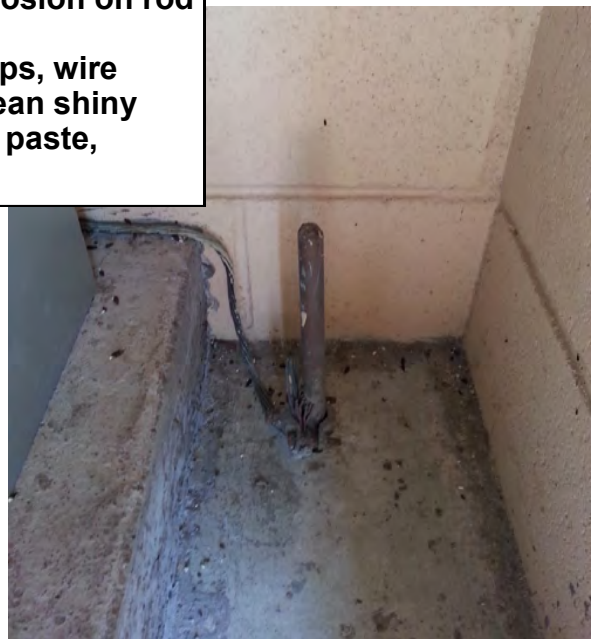
Ground Rods:

1. The Main ground rod was found corroded and the clamp connecting the Equipment Grounding Conductor (EGC) was loose. Further action required.
2. The other two ground clamps were found slightly corroded. Further action required.
3. AC leak current at the main ground rod was tested at 85 ~ 91 milliAmps (mA)
Very low leak current.
4. Equipment does appear to meet the minimum height requirements of Electrical Datum Plane (24" above highest tide level).
5. Main disconnects not clearly labeled on outside of building. Further action required.
6. "No Swimming" signs not posted at any of the marina entrances. Further action required.

Clamp on right side found loose, missing hardware, surface corrosion on rod

- I) Disassemble, clean and repair connections at both of the utility shed ground rods referenced on page 5. Clean all points of contact to bright, shiny metal, apply anticorrosion paste to points of contact before reassembly.

Need to disassemble clamps, wire brush rod and clamp to clean shiny metal, apply anticorrosion paste, reassemble and tighten

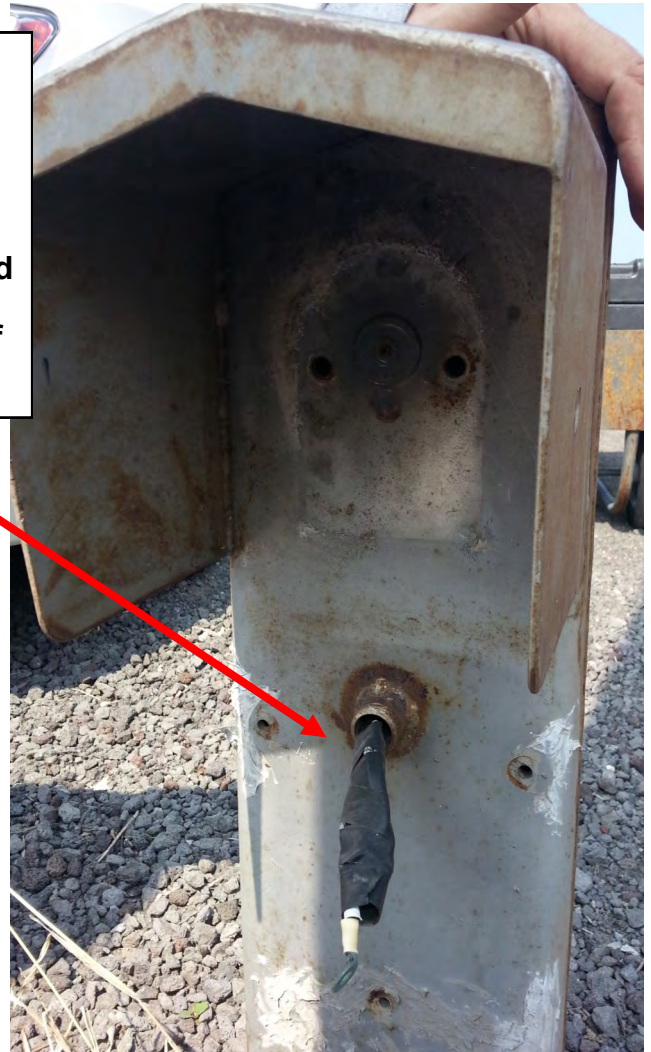
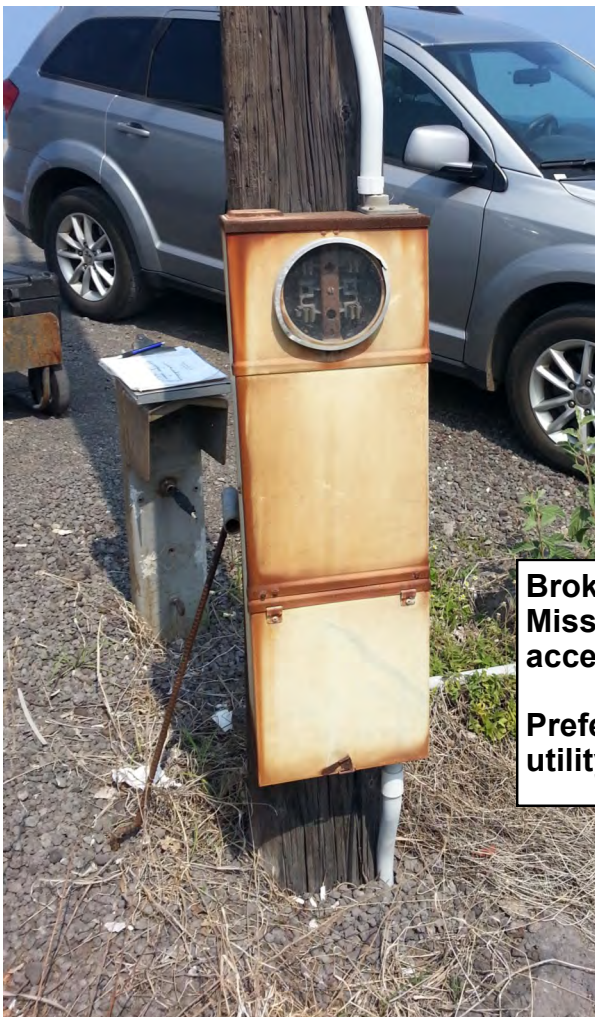
1. All of the coin - operated pedestals are in serious disrepair, and do not appear to have any over-current protection (circuit breaker). Pedestals are numbered as indicated on the attached harbor plan. Pedestals #4,5,7,8,9,10,11,12,17,18,19 are still energized & show evidence of tampering or vandalism. Imminent shock and fire hazard. Further action required.
2. Several of the pedestals are fed via conduits from the adjacent utility poles; conduits are broken, separated and torn loose from their mountings. Further action required.
3. The pedestal on the N/W end of the line on the North side of the marina is supplying several different vessels, all using undersized, household extension cords. Some of the cords travel great distances and join other cords in deteriorated condition. Possible arcing, fire, shock hazard.

Every pedestal inspected found in disrepair

Imminent shock hazard, possible arcing, fire hazard

**Broken plastic conduits, exposed live 120VAC wiring
Missing meters and old junction boxes invite easy
access for tampering**

- A) Highly recommend to immediately disconnect power to all of the coin - operated power pedestals at the source, and remove the pedestals to prevent further tampering.

**Recommend immediate disconnection at the top of
the nearby utility poles**

**Preferred disconnection point is at the top of each
utility pole**

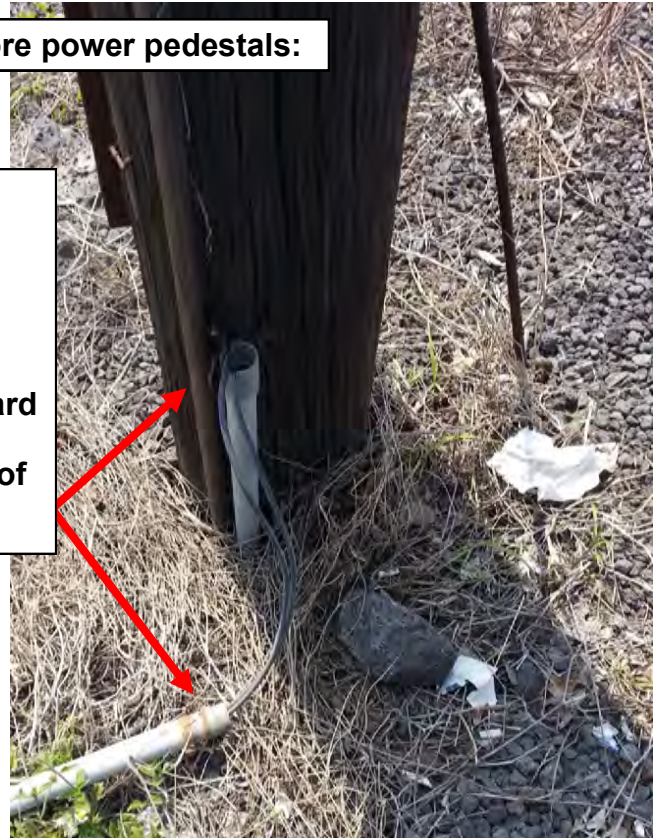
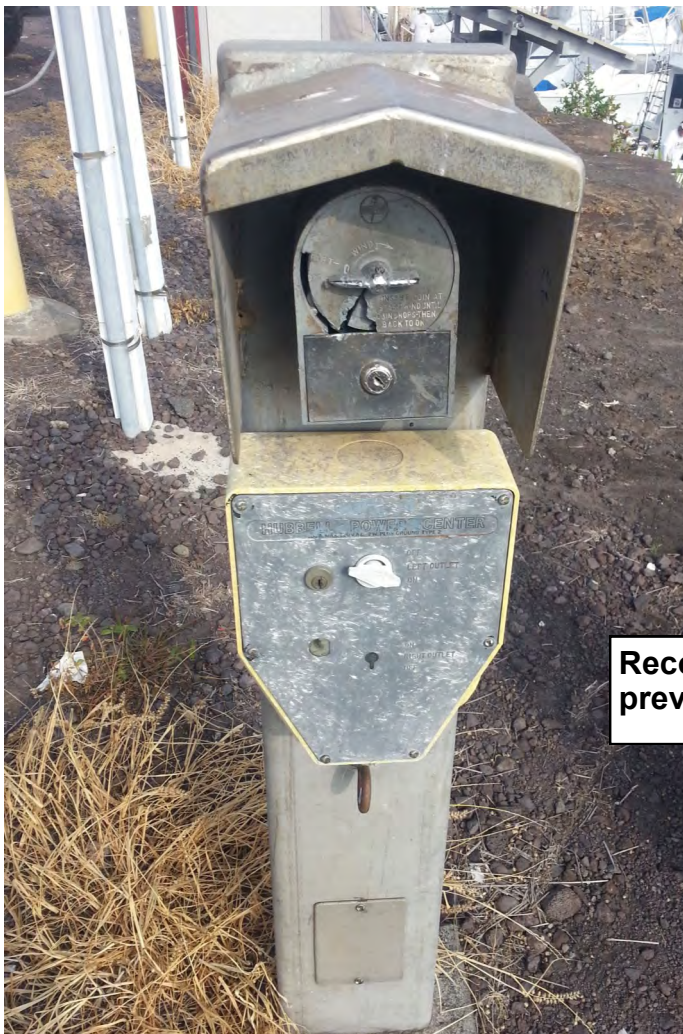
Every pedestal inspected found in disrepair

Imminent shock hazard, possible arcing, fire hazard

Recommend immediate disconnection at the top of the nearby utility poles

Recommend complete removal of pedestals to prevent further tampering

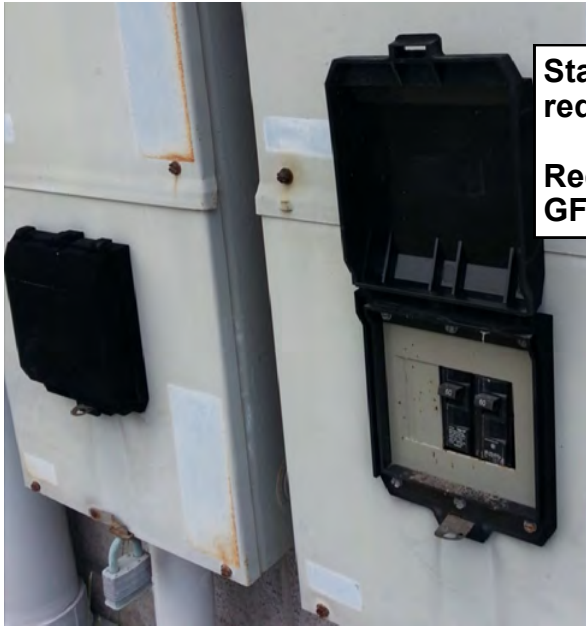
South Side Meters and Service Disconnects:

Standard breakers do not meet NEC Article 555 requirement for GFCI breakers

Recommend replacing breakers with 30mA trip GFCI breakers

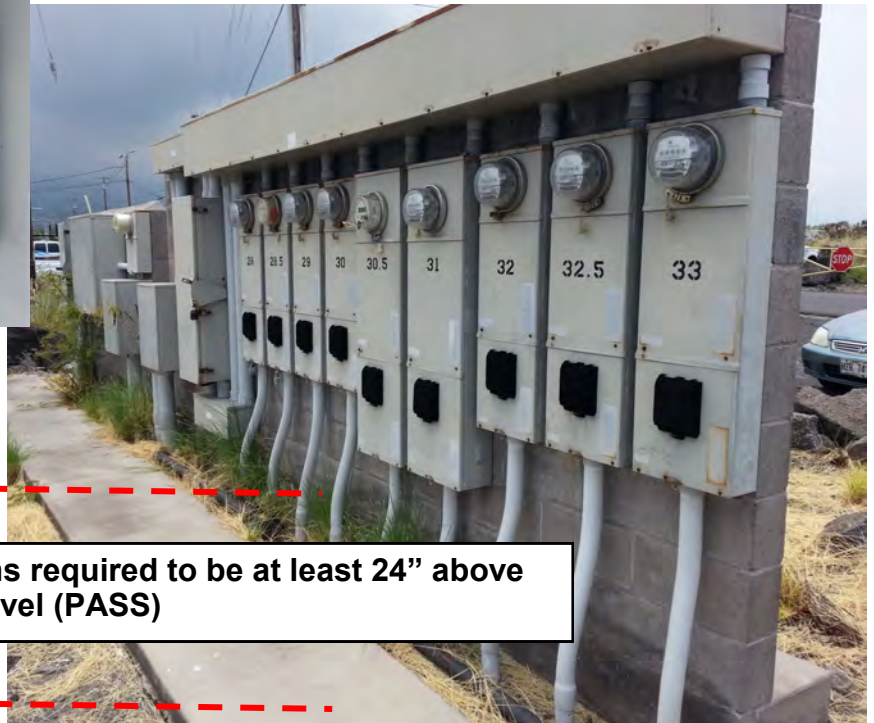
All electrical connections required to be at least 24" above maximum flood water level (PASS)

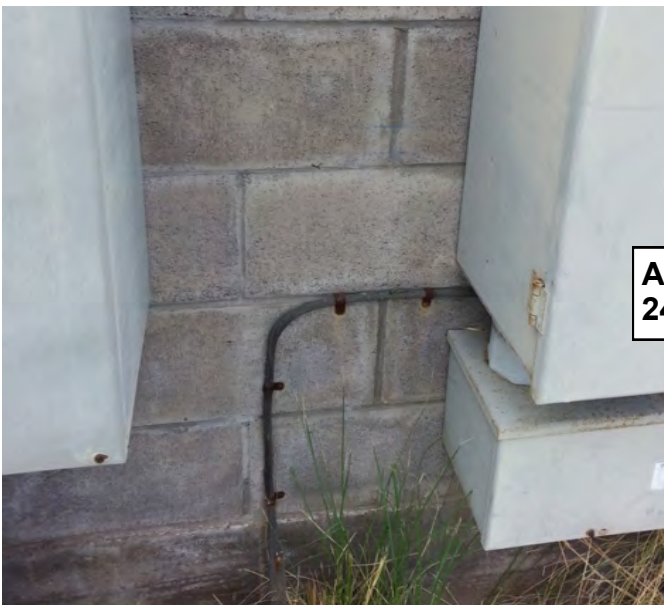
All electrical connections required to be at least 24" above maximum flood water level (PASS)

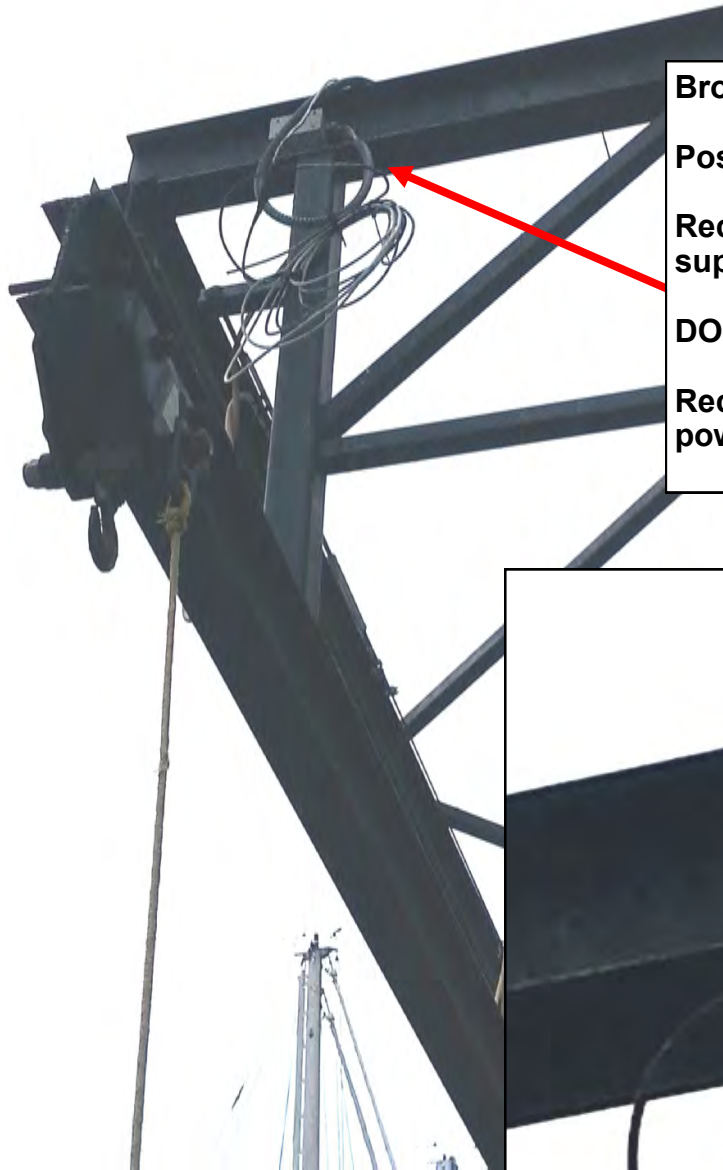
Steel Gantry Crane Near Fuel Dock / Sportfishing Office:

1. Steel crane power supply wiring noted with very deteriorated / broken conduit fittings, exposed wiring, in close proximity to public access area for sportfishing / diving charter guests. Due to the high foot traffic and presence of both salt and fresh water in this marina, this presents an imminent electrocution hazard, as well as a possible fire hazard. Further action required.
2. 120VAC receptacle on the patio at the S/W corner of the crane deteriorated, broken loose from mountings, not GFCI equipped. Possible shock hazard, Does not meet code.
3. None of the 120VAC receptacles in any of the bathrooms on the South side of the marina are GFCI equipped. Non code compliant. Possible shock hazard. Further action required.

Broken conduit, exposed live 120VAC wires
Possible electrocution, fire hazard
Recommend immediate disconnection of supply circuit until repairs can be completed
DOES NOT MEET CODE
Recommend GFCI circuit breaker for crane power source

- C) Highly recommend to immediately disconnect the power to all of the steel gantry crane components at the source. It may be advisable to install in-line GFCI devices as a temporary solution until permanent rewiring of the crane can be completed.

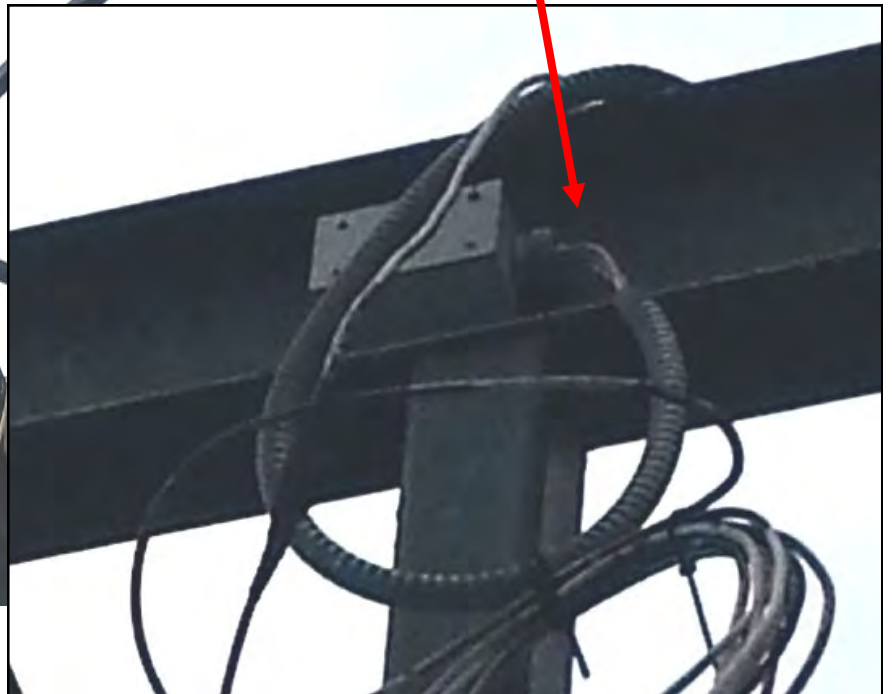
The location of the crane structure is right near the offloading site for diving / sportfishing guests

Several times during the inspection, guests were observed in wet, bare feet touching the crane uprights; imminent shock hazard

Recommend immediate disconnection of supply circuit until repairs can be completed

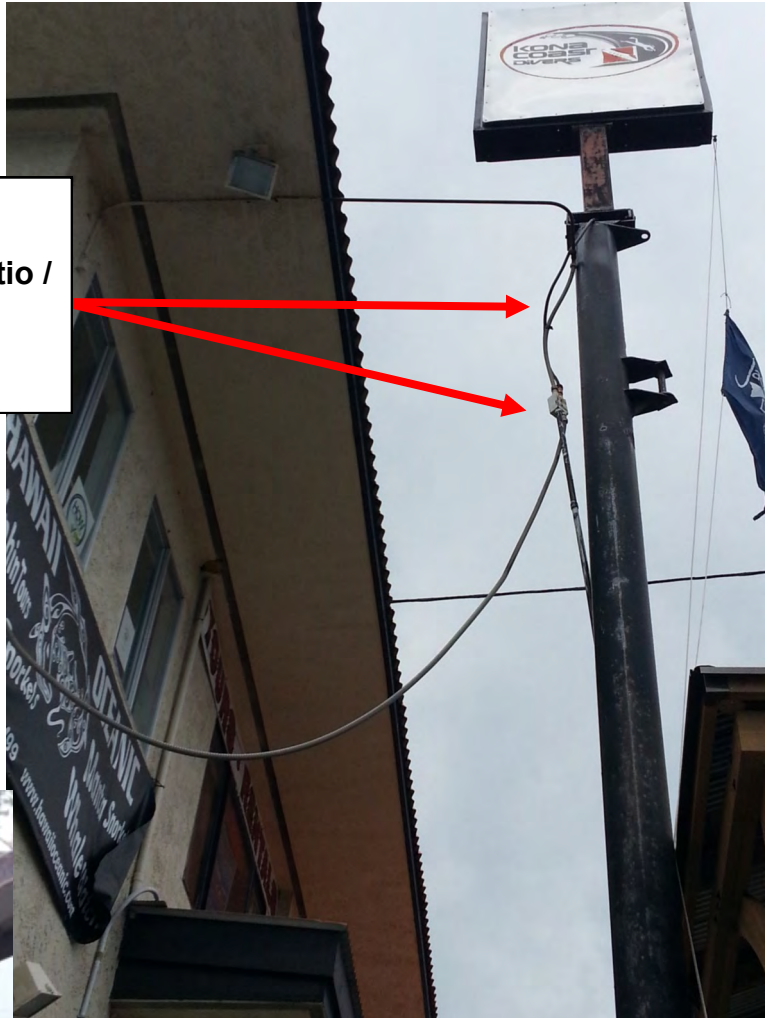
Broken conduits, unsecured wiring

If conduit fails, it could fall directly onto patio / guest area

Possible shock, fire hazard

- D) Repair the conduits and broken hardware referenced on page 5 near the entrance to the sport-fishing building.
- E) Repair the broken 120VAC receptacle at the S/W corner of the patio near the sportfishing building. Code requires GFCI receptacle with raintight cover.

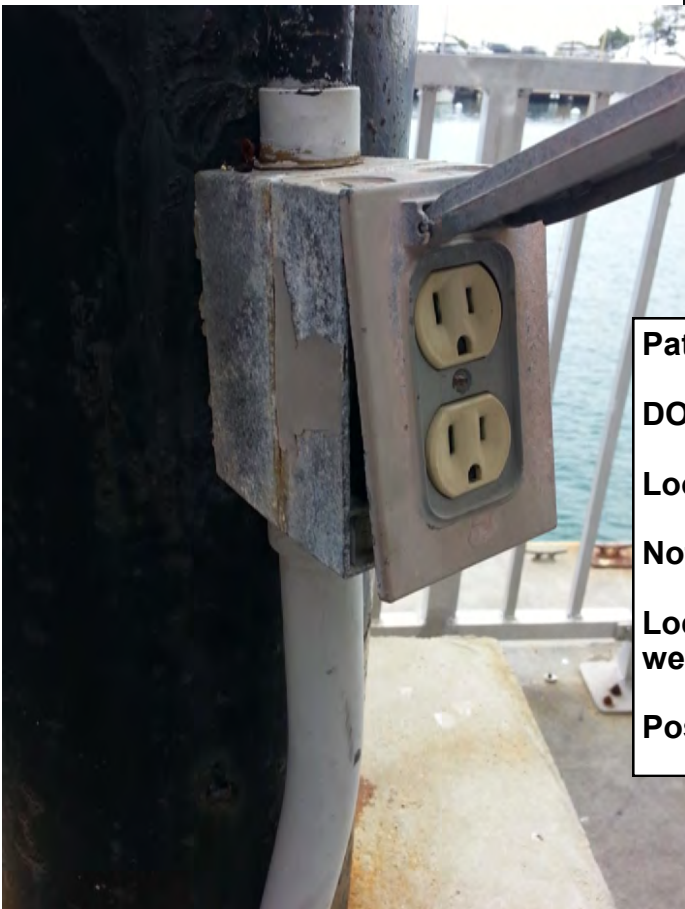
Patio area 120VAC receptacle:

DOES NOT MEET CODE

Loose, unsecured receptacle

Possible shock hazard

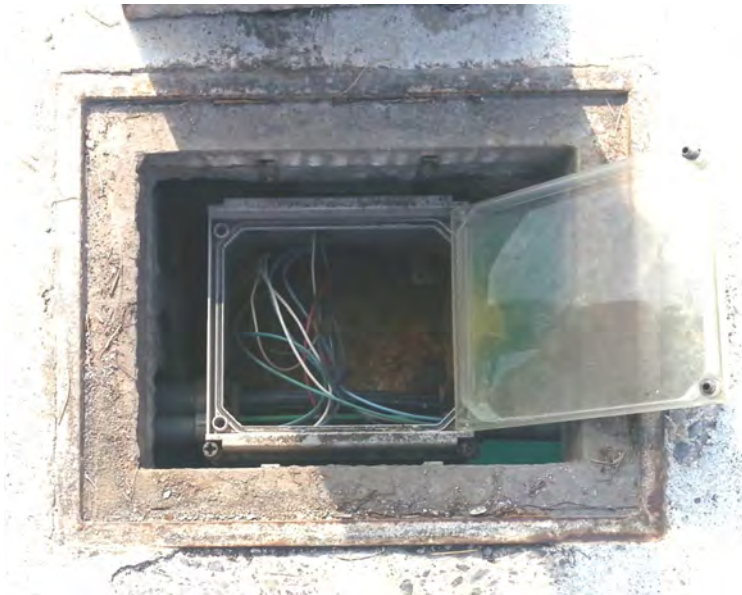
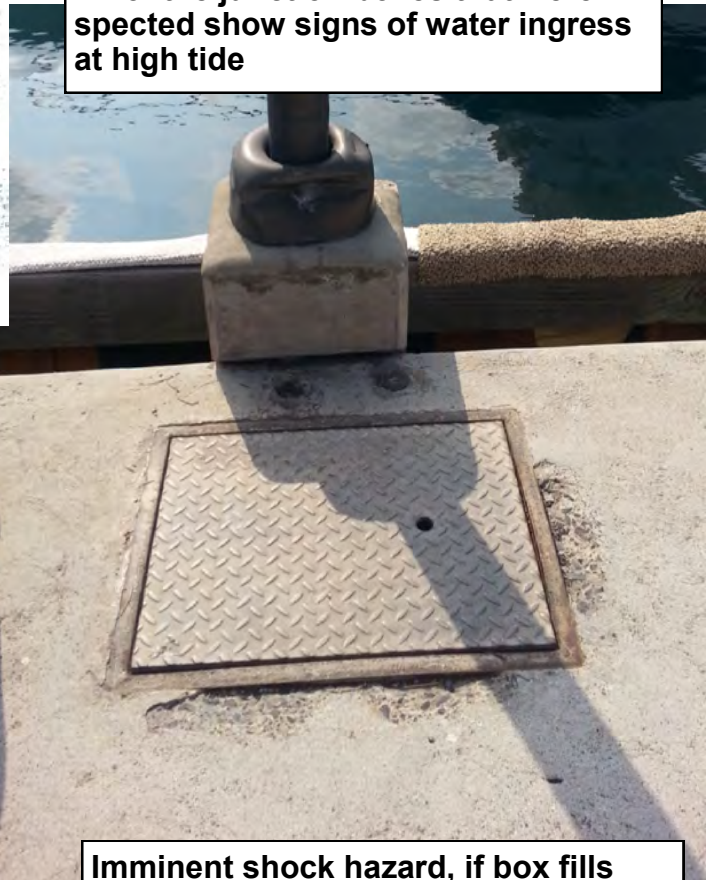
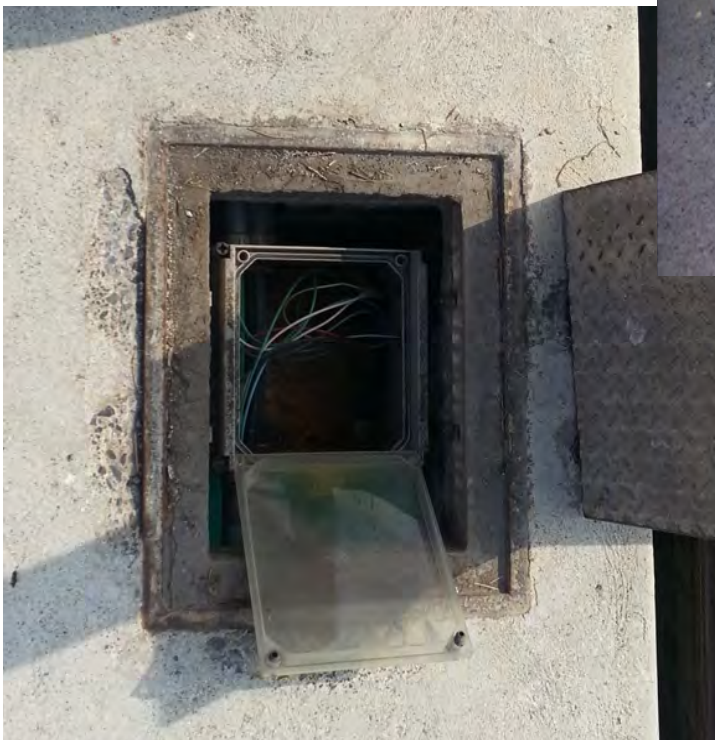
**Below Deck 120VAC Dock Lighting:
(3 shown, all others similar)**

1. Junction boxes are located on fixed (non floating) concrete causeways, do not meet the minimum height requirements of the Electrical Datum Plane. Non - waterproof splices used, signs of water intrusion was noted in every junction box that was inspected. Due to the presence of both salt and fresh water in this marina, this presents an imminent electrocution hazard, as well as a possible fire hazard. Further action required.
2. The dock lighting system is not equipped with GFCI protection. Does not meet code.

All of the dock lighting junction boxes are below the minimum height requirements (2ft above highest tide level)

DOES NOT MEET CODE

All of the junction boxes that were inspected show signs of water ingress at high tide

Imminent shock hazard, if box fills with water while lighting circuits are energized

Possible arcing, fire hazard

- B) Highly recommend to immediately disconnect the power to all of the dock lighting circuits at the source. It may be advisable to install small, solar-powered pathway lights as a temporary solution until permanent rewiring of the lights can be completed.

Recommend immediate disconnection of all lighting circuits until repairs can be completed.

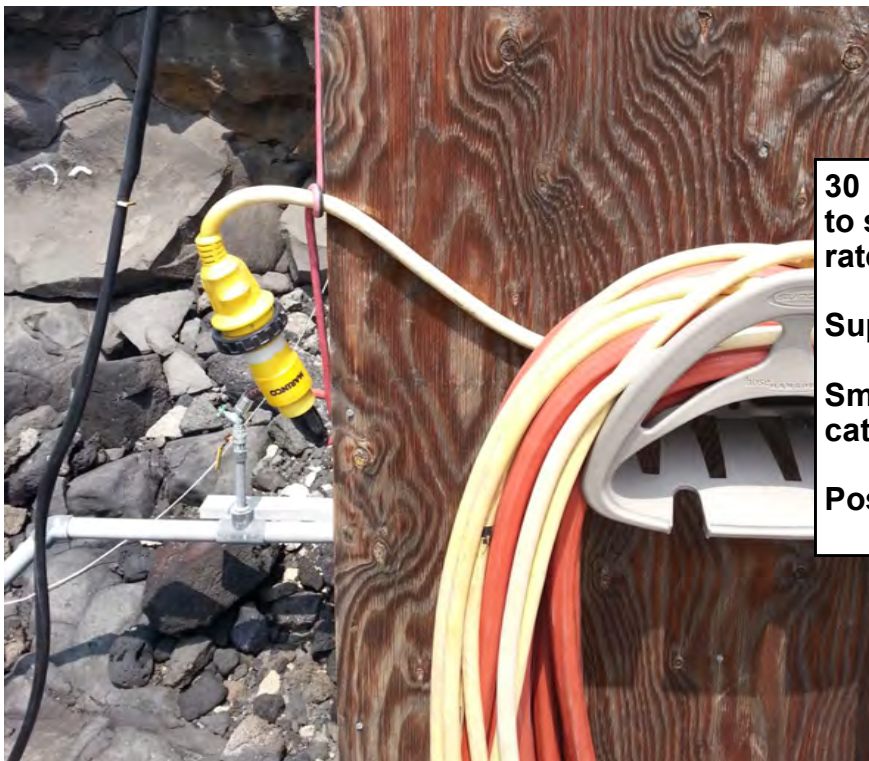
30 Amp marine power cord, connected to small - gauge household indoor rated extension cord

Supplied by 30A breaker

Possible fire, shock hazard

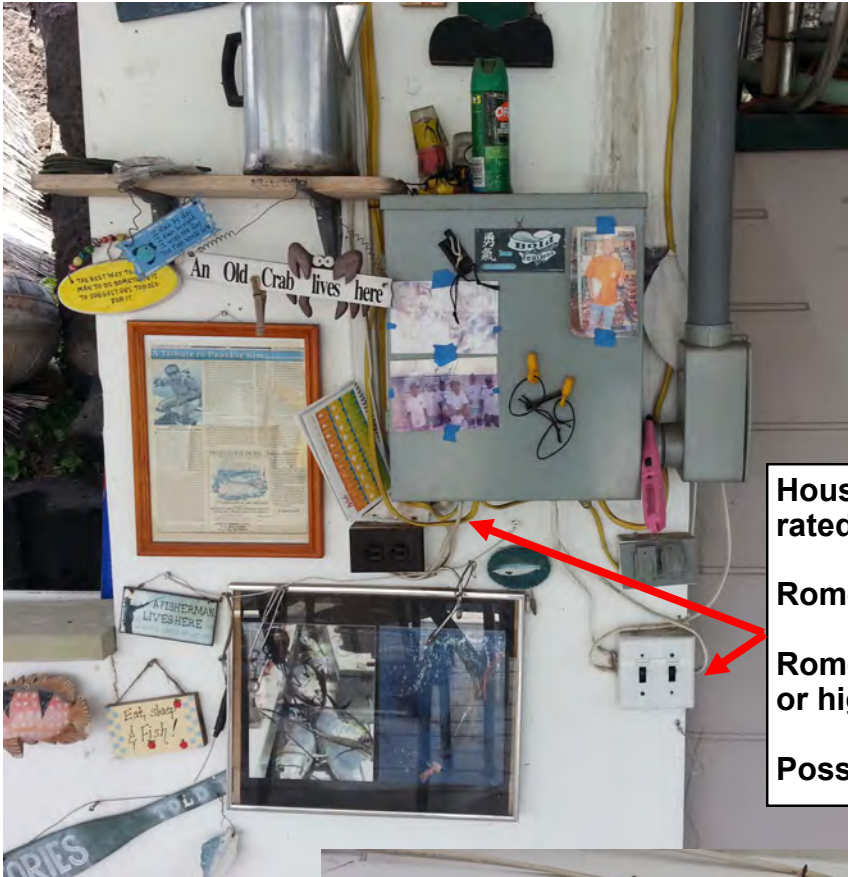
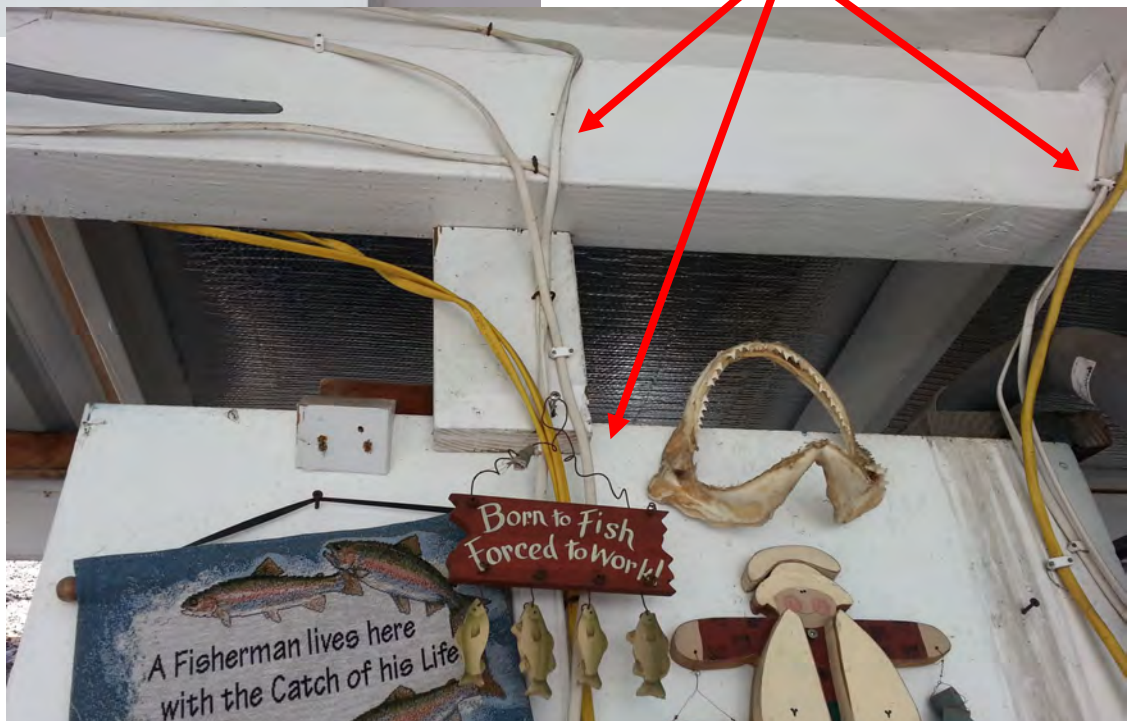
Boatowner - Installed shore power:

Household load center, feeding indoor - rated Romex cabling

Romex not rated for exposed applications

Romex cable not rated for exposure to UV, or high moisture applications

Possible fire, shock hazard

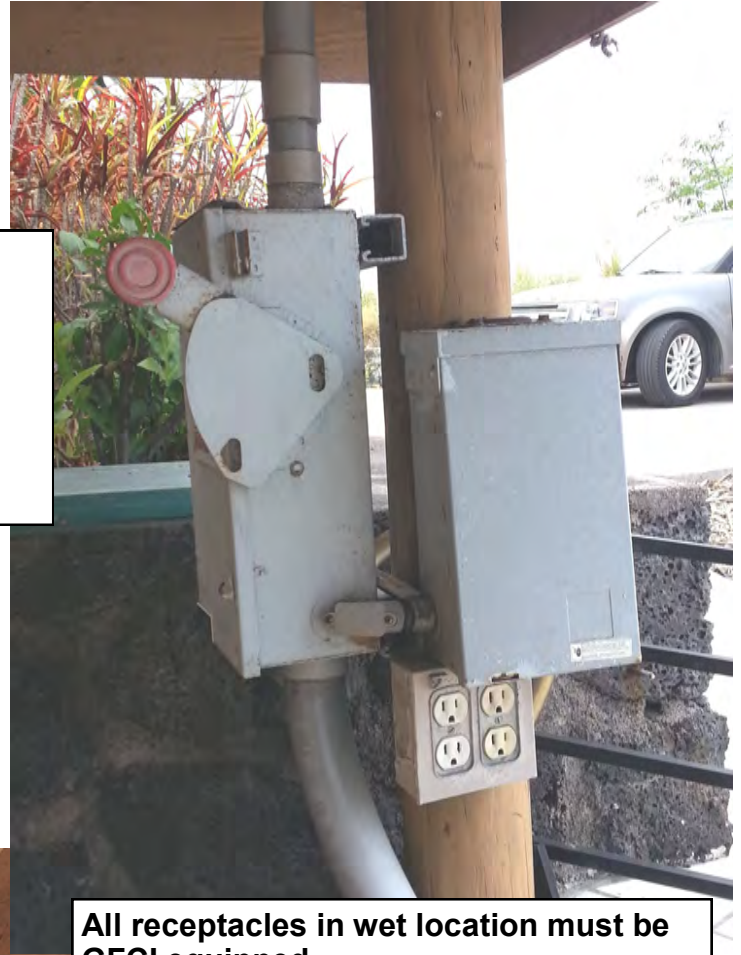
Not equipped with GFCI breaker

DOES NOT MEET CODE

All receptacles in wet location must be GFCI equipped

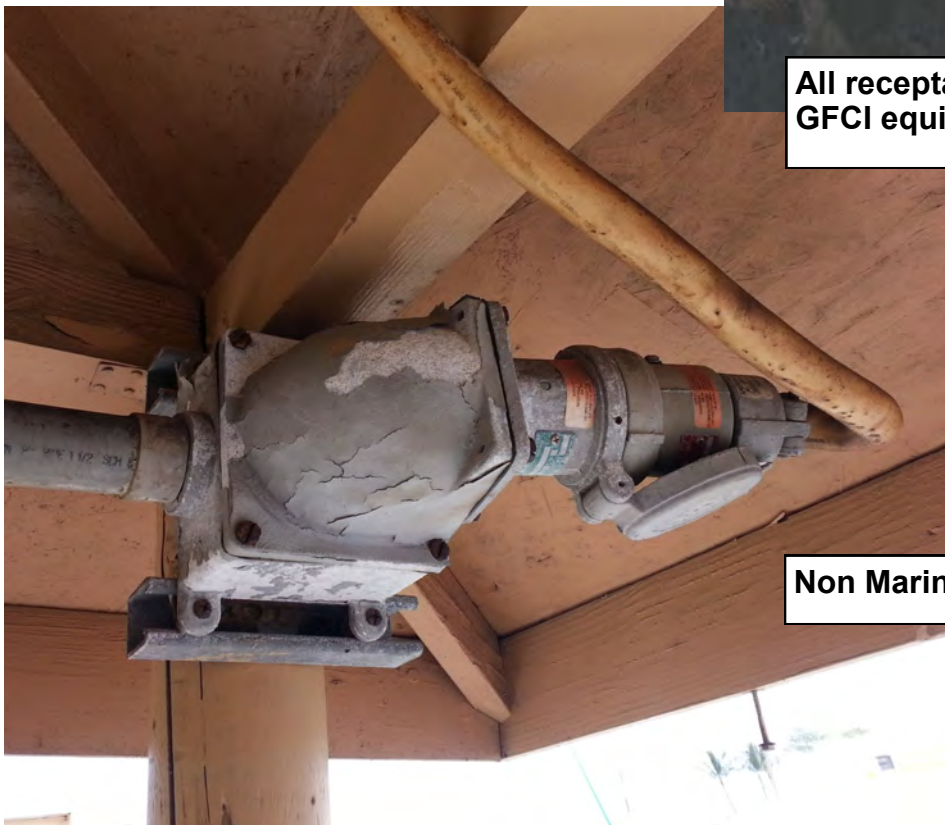
Non Marine cord fittings and receptacle

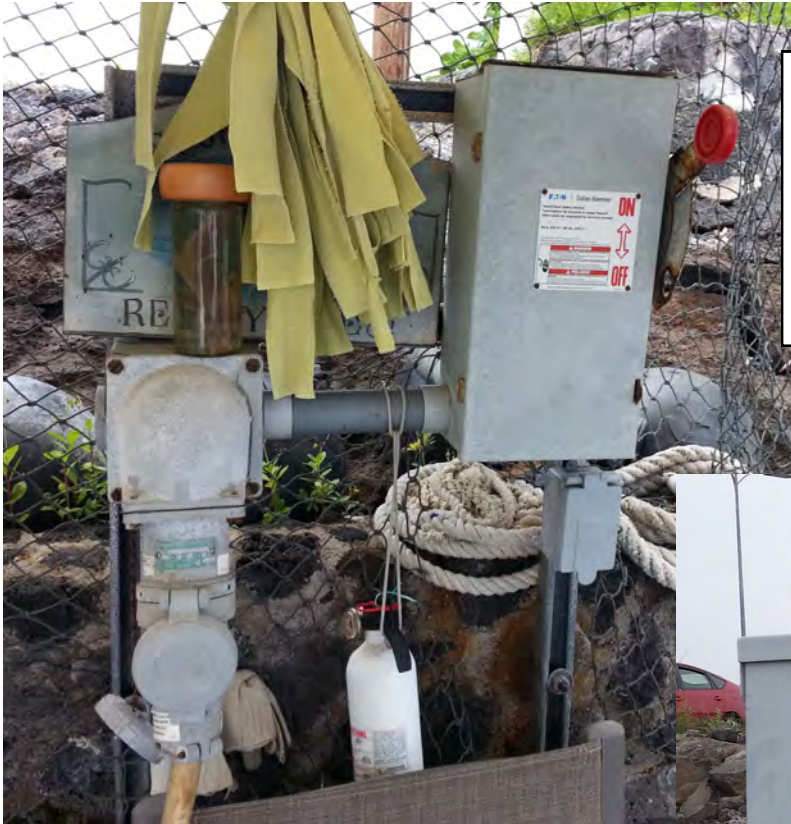
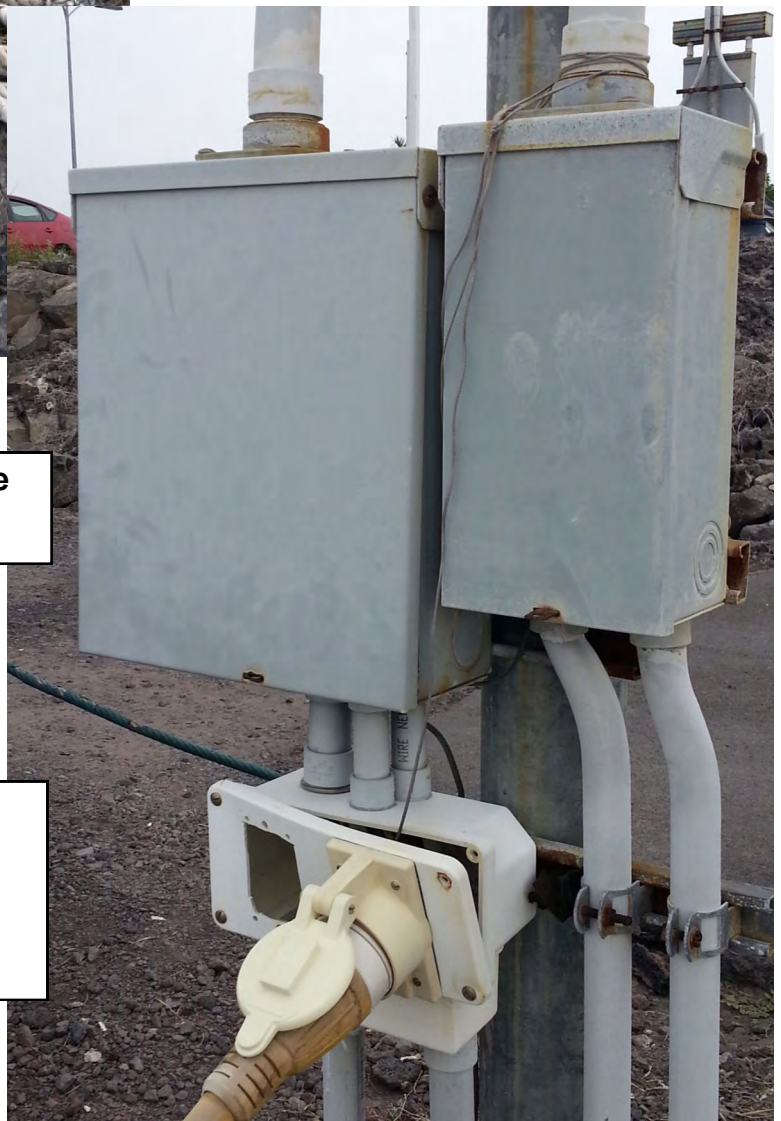
Boatowner - Installed shore power:

Non GFCI receptacles

Non Marine shore cord receptacle

Missing, broken components

Possible arcing, fire hazard

Possible shock hazard

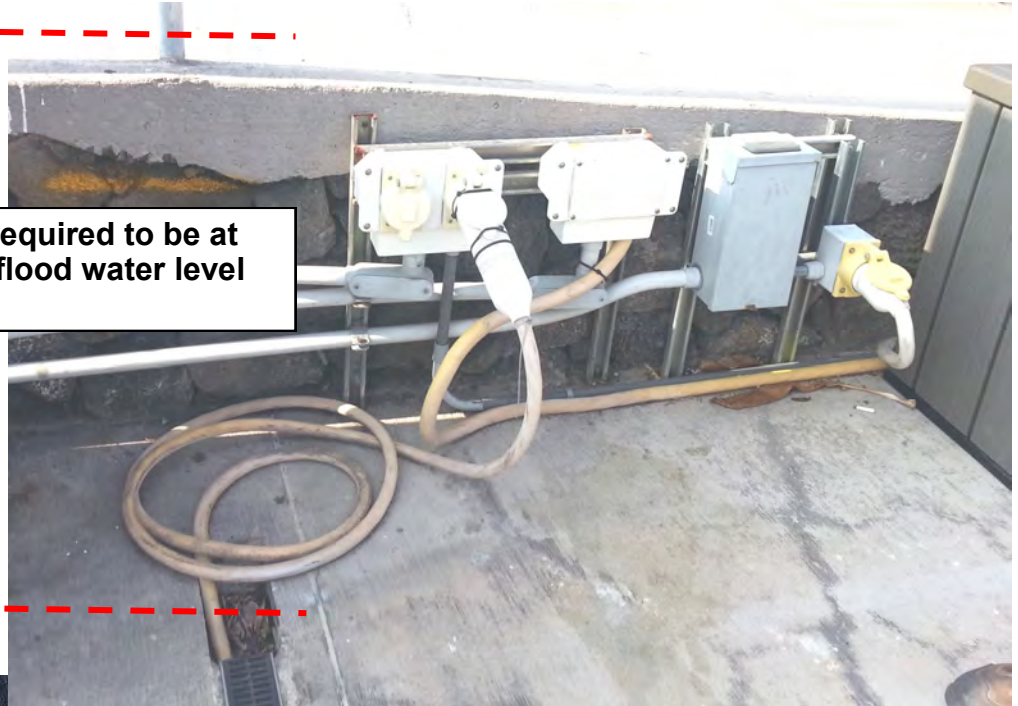
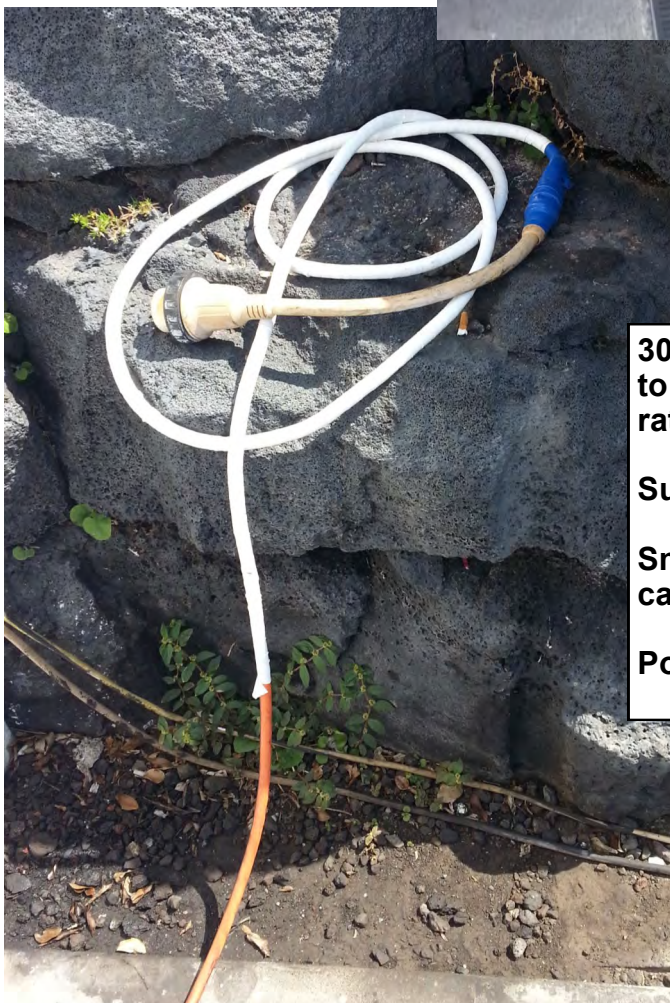
Boatowner - Installed shore power:

All electrical connections required to be at least 24" above maximum flood water level (DOES NOT MEET CODE)

30 Amp marine power cord, connected to small - gauge household indoor rated extension cord

Supplied by 30A breaker

Possible fire, shock hazard

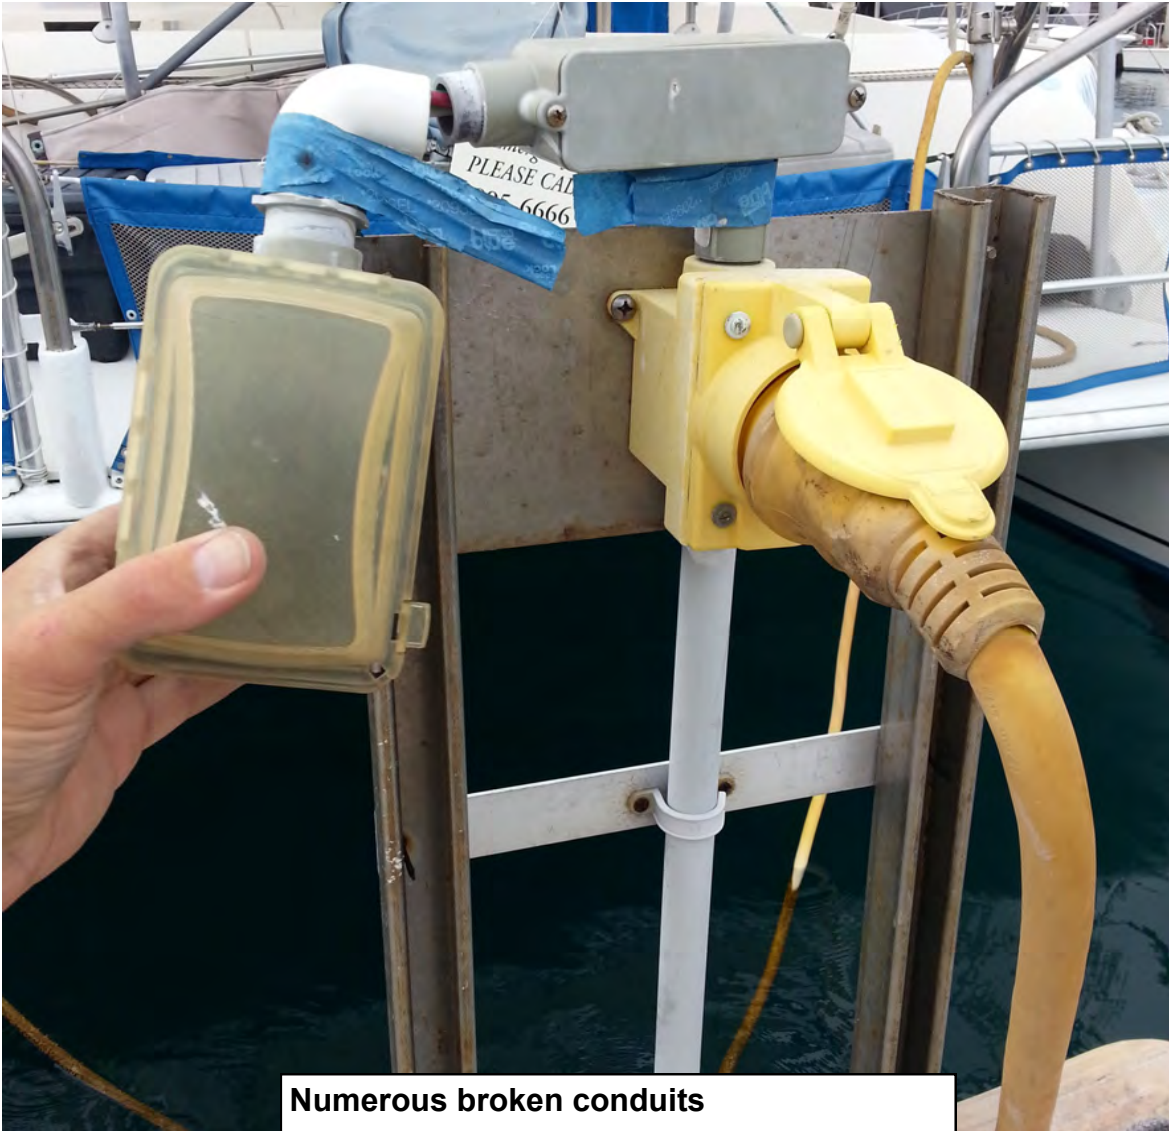
Concrete Causeway / Dock - Mounted Shore Power:

**Numerous broken conduits
Missing, broken components
Non GFCI breakers
Possible shock, fire hazard
DOES NOT MEET CODE**

- G) Recommend to retain the services of a qualified electrical contractor who is familiar with the requirements of the NFPA 303 standard, to discuss the feasibility of installation of GFCI breakers at each shore power pedestal. NEC allows the use of up to 100 milliamp trip breakers. If 100mA breakers are not available to fit the existing pedestals, it may be possible to use 30mA trip breakers but more nuisance tripping will likely occur.

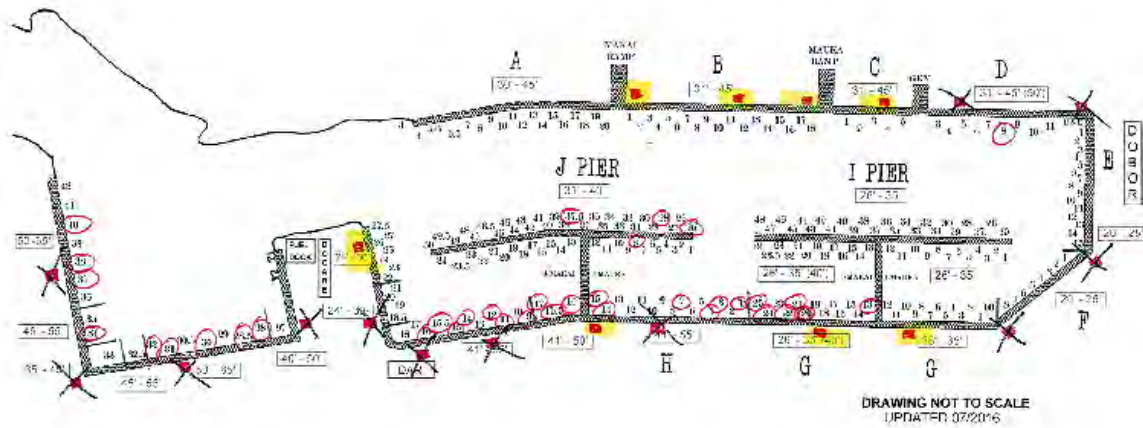
HONOKŌHAU SMALL BOAT HARBOR
KAILUA-KONA, HAWAII

✗ = doesn't work could still be electrified
